Naylor Road Metro Station Area Accessibility Study

Pedestrian and Bicycle Metro Station Access
Transportation Land-Use Connection (TLC)

The Maryland-National Capital Park and
Planning Commission

May 2011

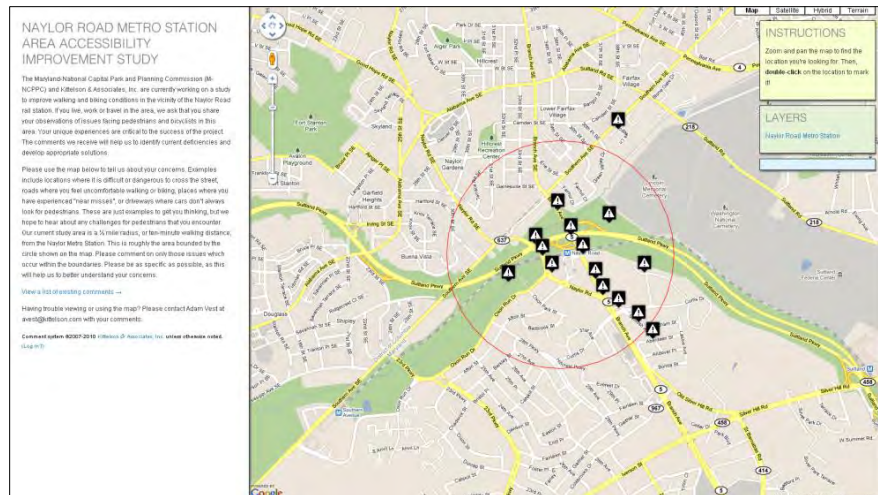
Screen-capture of the public comment based website used to gather public observations and issues during the project.

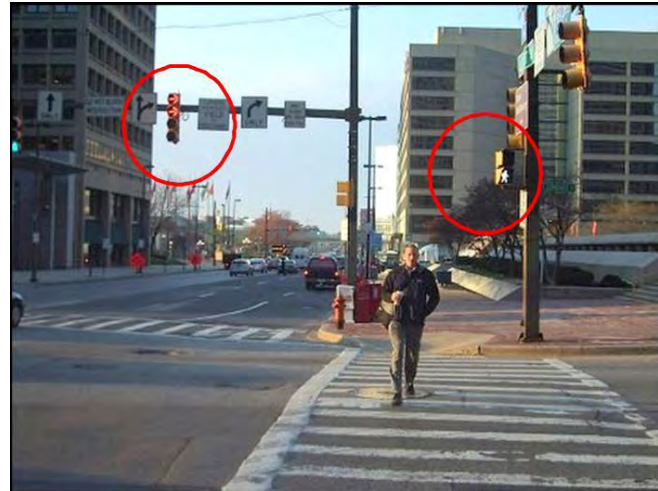
Description: Pedestrians are allowed to begin crossing at the crosswalk before conflicting vehicles start moving. For example, right-turning vehicles may have a red light for 5 to 7 seconds while pedestrians and through vehicles are allowed to begin through the intersection.

Effectiveness: Pedestrians get a head start on vehicles in crossing the roadway, increasing the percentage of turning drivers yielding to pedestrians. Note that right-turn-on-red is often prohibited in conjunction with leading pedestrian intervals

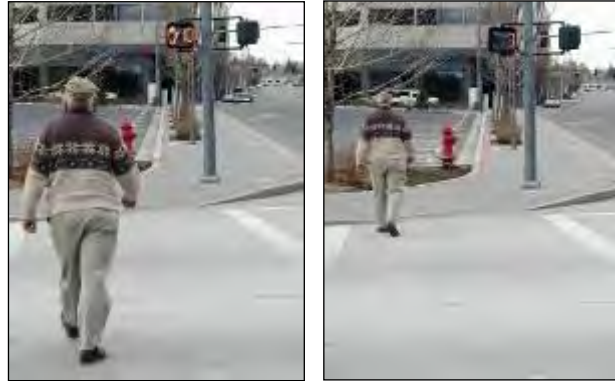
Description: Newer pedestrian signal heads, contrasted with static Walk/Flash Don't Walk signals, inform pedestrians of the time remaining to cross the street with a countdown on the signal head.

Effectiveness: Fewer pedestrians crossing the street late in the countdown, as compared to signal heads with only the Flash Don't Walk light. Fewer pedestrians left in crosswalk in steady don't walk phase.

Application in Study Area: The Metro Entrance on Branch Avenue does not have a pedestrian signal phase. Pedestrians were observed frequently crossing at this intersection. As part of the installation of crosswalks and sidewalks at this location, pedestrian countdown signals should be installed for MUTCD compliance and pedestrian safety.

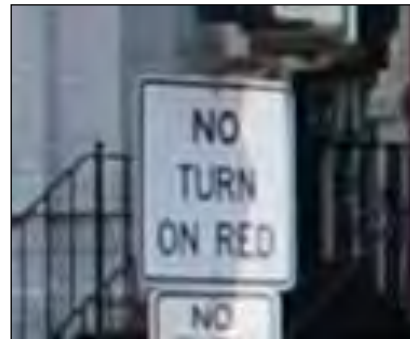
Description: Reduces conflicts between cars and pedestrians by prohibiting cars to turn right, into the path of crossing pedestrians. This treatment may be deployed on a full-time or restricted basis.

Effectiveness: Electronic NRTOR signs have been shown to decrease pedestrian/vehicle conflicts significantly. According to the AASHTO Highway Safety Manual, NRTOR also significantly reduces pedestrian crashes.

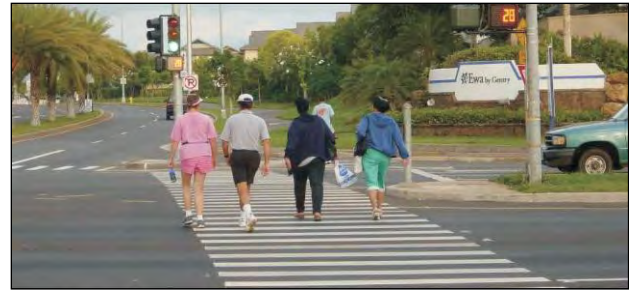
Description: Reduce the amount of green time, and therefore overall cycle length, at intersections to decrease the amount of time pedestrians wait to cross the street.

Effectiveness: By reducing the average amount of time pedestrians wait to cross the street, pedestrians are more likely to cross during the Walk phase.

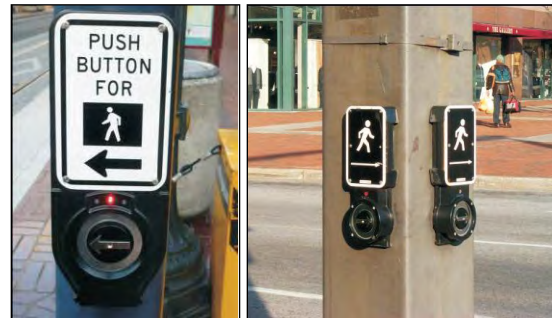
Description: Signs above the pedestrian push-button indicate direction of crossing. "Confirm" press buttons acknowledge activation through a light or sound after called by a pedestrian.

Effectiveness: Confirm press buttons have been shown to increase the number of pedestrians using the push-button, and more pedestrians wait for the Walk phase at the signal.

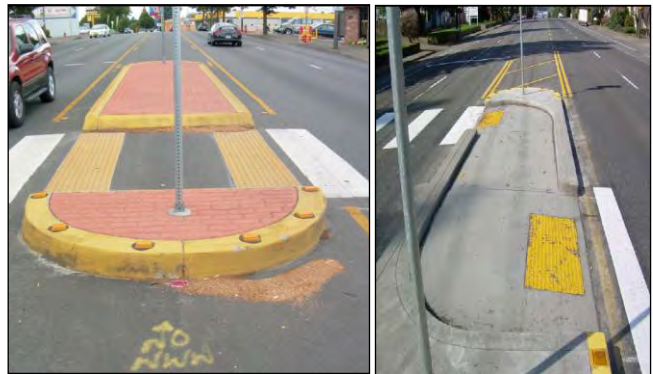
Description: Provide a protected area in the middle of a crosswalk for pedestrians to stop while crossing. Interim islands consist of striping on the pavement to identify pedestrian space, while fully constructed islands typically include curbs and signs notifying drivers to avoid the location.

Effectiveness: Installing raised medians have been shown to reduce the number of crashes at marked and unmarked crosswalks, as documented in the *Desktop Reference for Crash Reduction Factors*

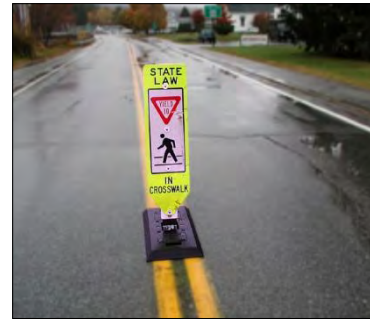
Description: Signs placed in the middle of crosswalks to increase driver awareness of pedestrians and the legal responsibility to yield right-of-way to pedestrians in crosswalks

Effectiveness: Increases the number of drivers that yield to pedestrians in the crosswalk.

Application in Study Area: A sign is recommended at the painted crosswalks at each leg of the roundabouts on Naylor Road.

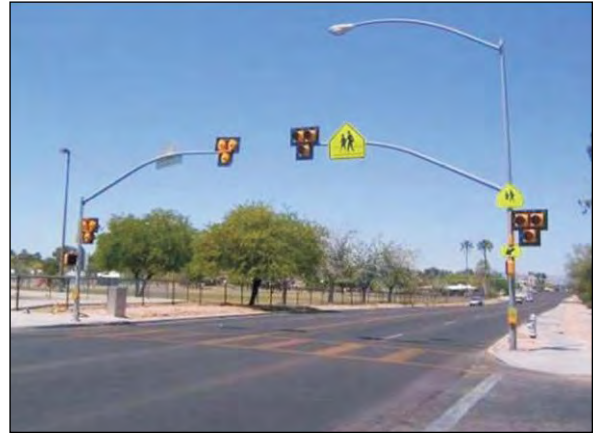
PEDESTRIAN HYBRID SIGNAL

Description: The pedestrian activated signal (also known as a HAWK signal), unlit when not in use, begins with a flashing yellow light altering drivers to slow. A solid red light requires drivers to stop while pedestrians have the right-of-way to cross the street. While the pedestrian signal is in the Flash Don't Walk Phase, the overhead signal flashes red, and drivers may proceed if the crosswalk is clear.

Effectiveness: Studies show that hybrid signals result in over 95 percent of drivers yielding to pedestrians. Moreover, drivers experience less delay at hybrid signals compared to other signalized intersections.

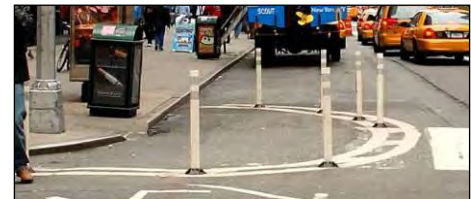
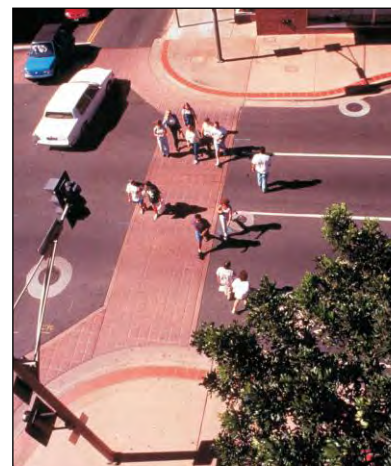
Implementation Considerations: Curb extensions are more easily installed along roadways with on-street parking since not all lanes are used for through traffic. They may be installed at intersections or mid-block crossings.

Application in Study Area: Curb extensions at the intersection of Oxon Run Drive/Oxon Park Street would significantly reduce crossing distances and better use the wasted space.

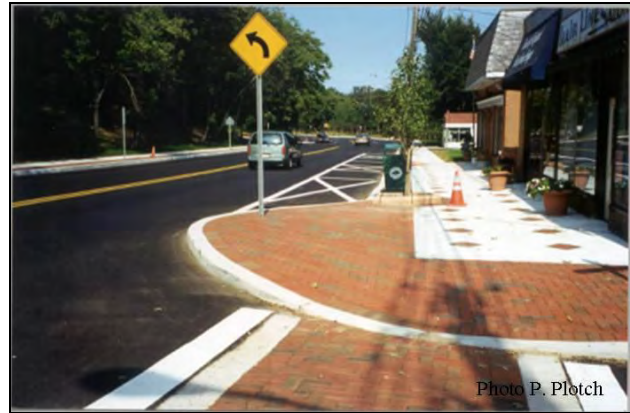
Application in Study Area: The Metro entrance on Branch Avenue includes a large radius for the southbound right-turn that is recommended for reduction. Vehicles on Branch Avenue are able to turn into the Metro station while maintaining a relatively high speed. Reducing the turning radius would also reduce the total crossing distance for pedestrians.

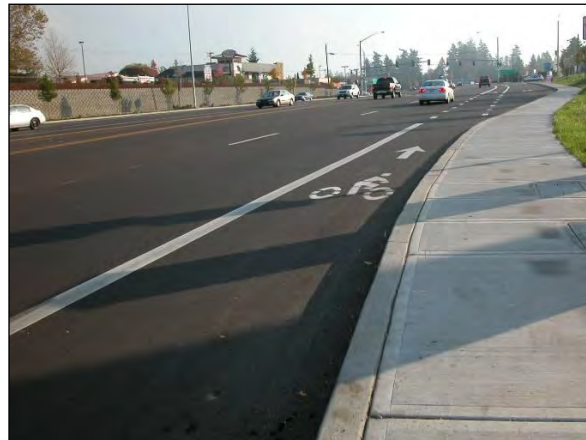
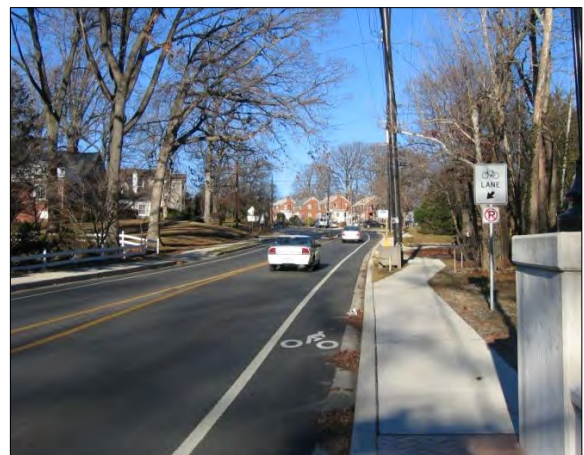
Compliance with Standards: AASHTO recommends a minimum width of 5 feet for bike lanes adjacent to parking, curbs, or guardrails. If additional space is available, a bicycle lane buffer can be used to provide additional comfort to riders. Use bicycle lane word and/or symbol and arrow markings (MUTCD Figure 9C-3) to define the bike lane and designate that portion of the street for preferential use by bicyclists.

Application in Study Area: Bike lanes on Branch Avenue would help establish cyclists on a higher speed roadway.

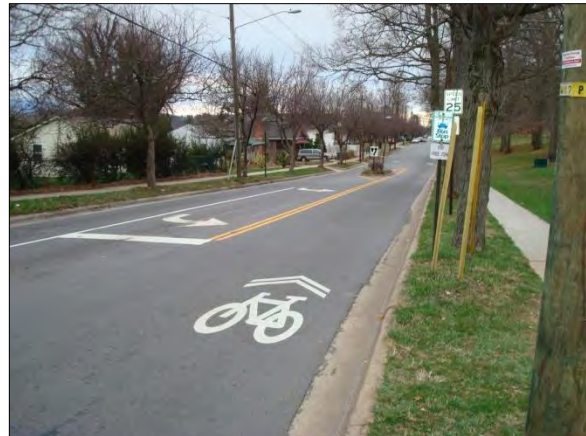
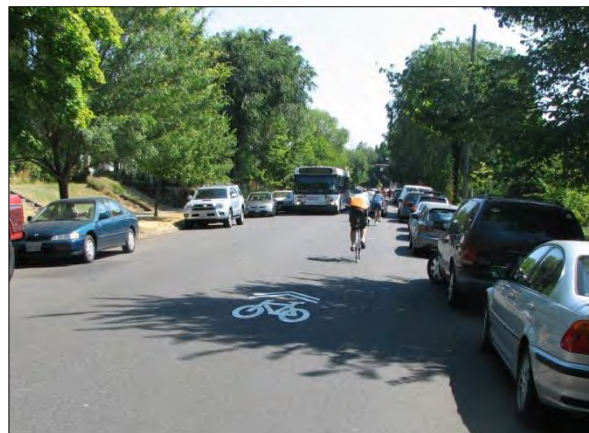
Compliance with Standards: The MUTCD outlines guidance for sharrows in section 9C.07. Markings should be placed every 100 to 250 feet along bike routes.

Application in Study Area: Shared lane markings on Naylor Road and Oxon Run Drive will help establish cyclists on those roadways. Furthermore, shared lane markings should also be considered at both Naylor Road roundabouts.

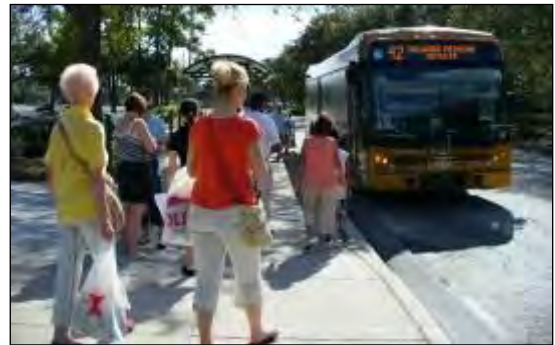
Description: Bus stops located close to one another can be consolidated into a single stop, reducing the total number of stops the bus has to make and concentrating boardings/alightings at one location. Bus stops can also be relocated to improve access to existing sidewalks, crosswalks, or destinations.

Effectiveness: Reducing the number of stops from 10 per mile to 8 per mile increases average bus speeds by 1.5 minutes/mile or more, depending on average dwell time at stops.

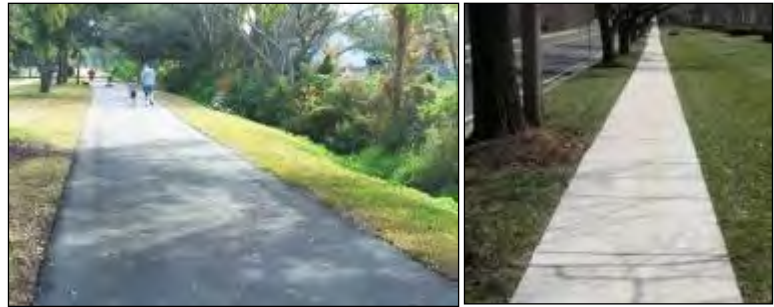
Description: Sidewalks and multiuse pathways are the primary facilities for pedestrians to travel and provide mobility to various destinations.

Effectiveness: Safe and comfortable walkways have been shown to increase pedestrian use.

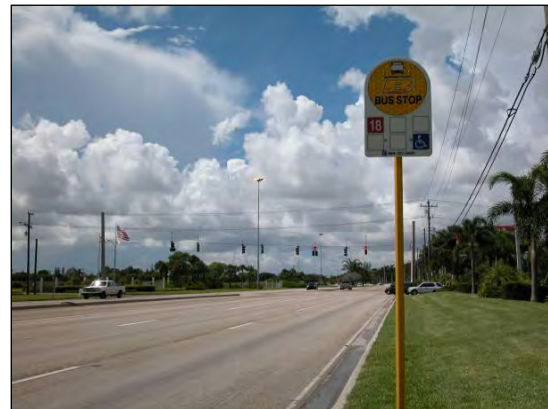
Description: Bus stops located along open-section roadways do not have the typical amenities of other stops, and usually only include a signing marking the stop. Concrete pads for boarding/alighting passengers at stops should be provided.

Effectiveness: Concrete pads further signify the presence of a bus stop, provide a location for passengers to wait comfortably, and ease passenger loading.

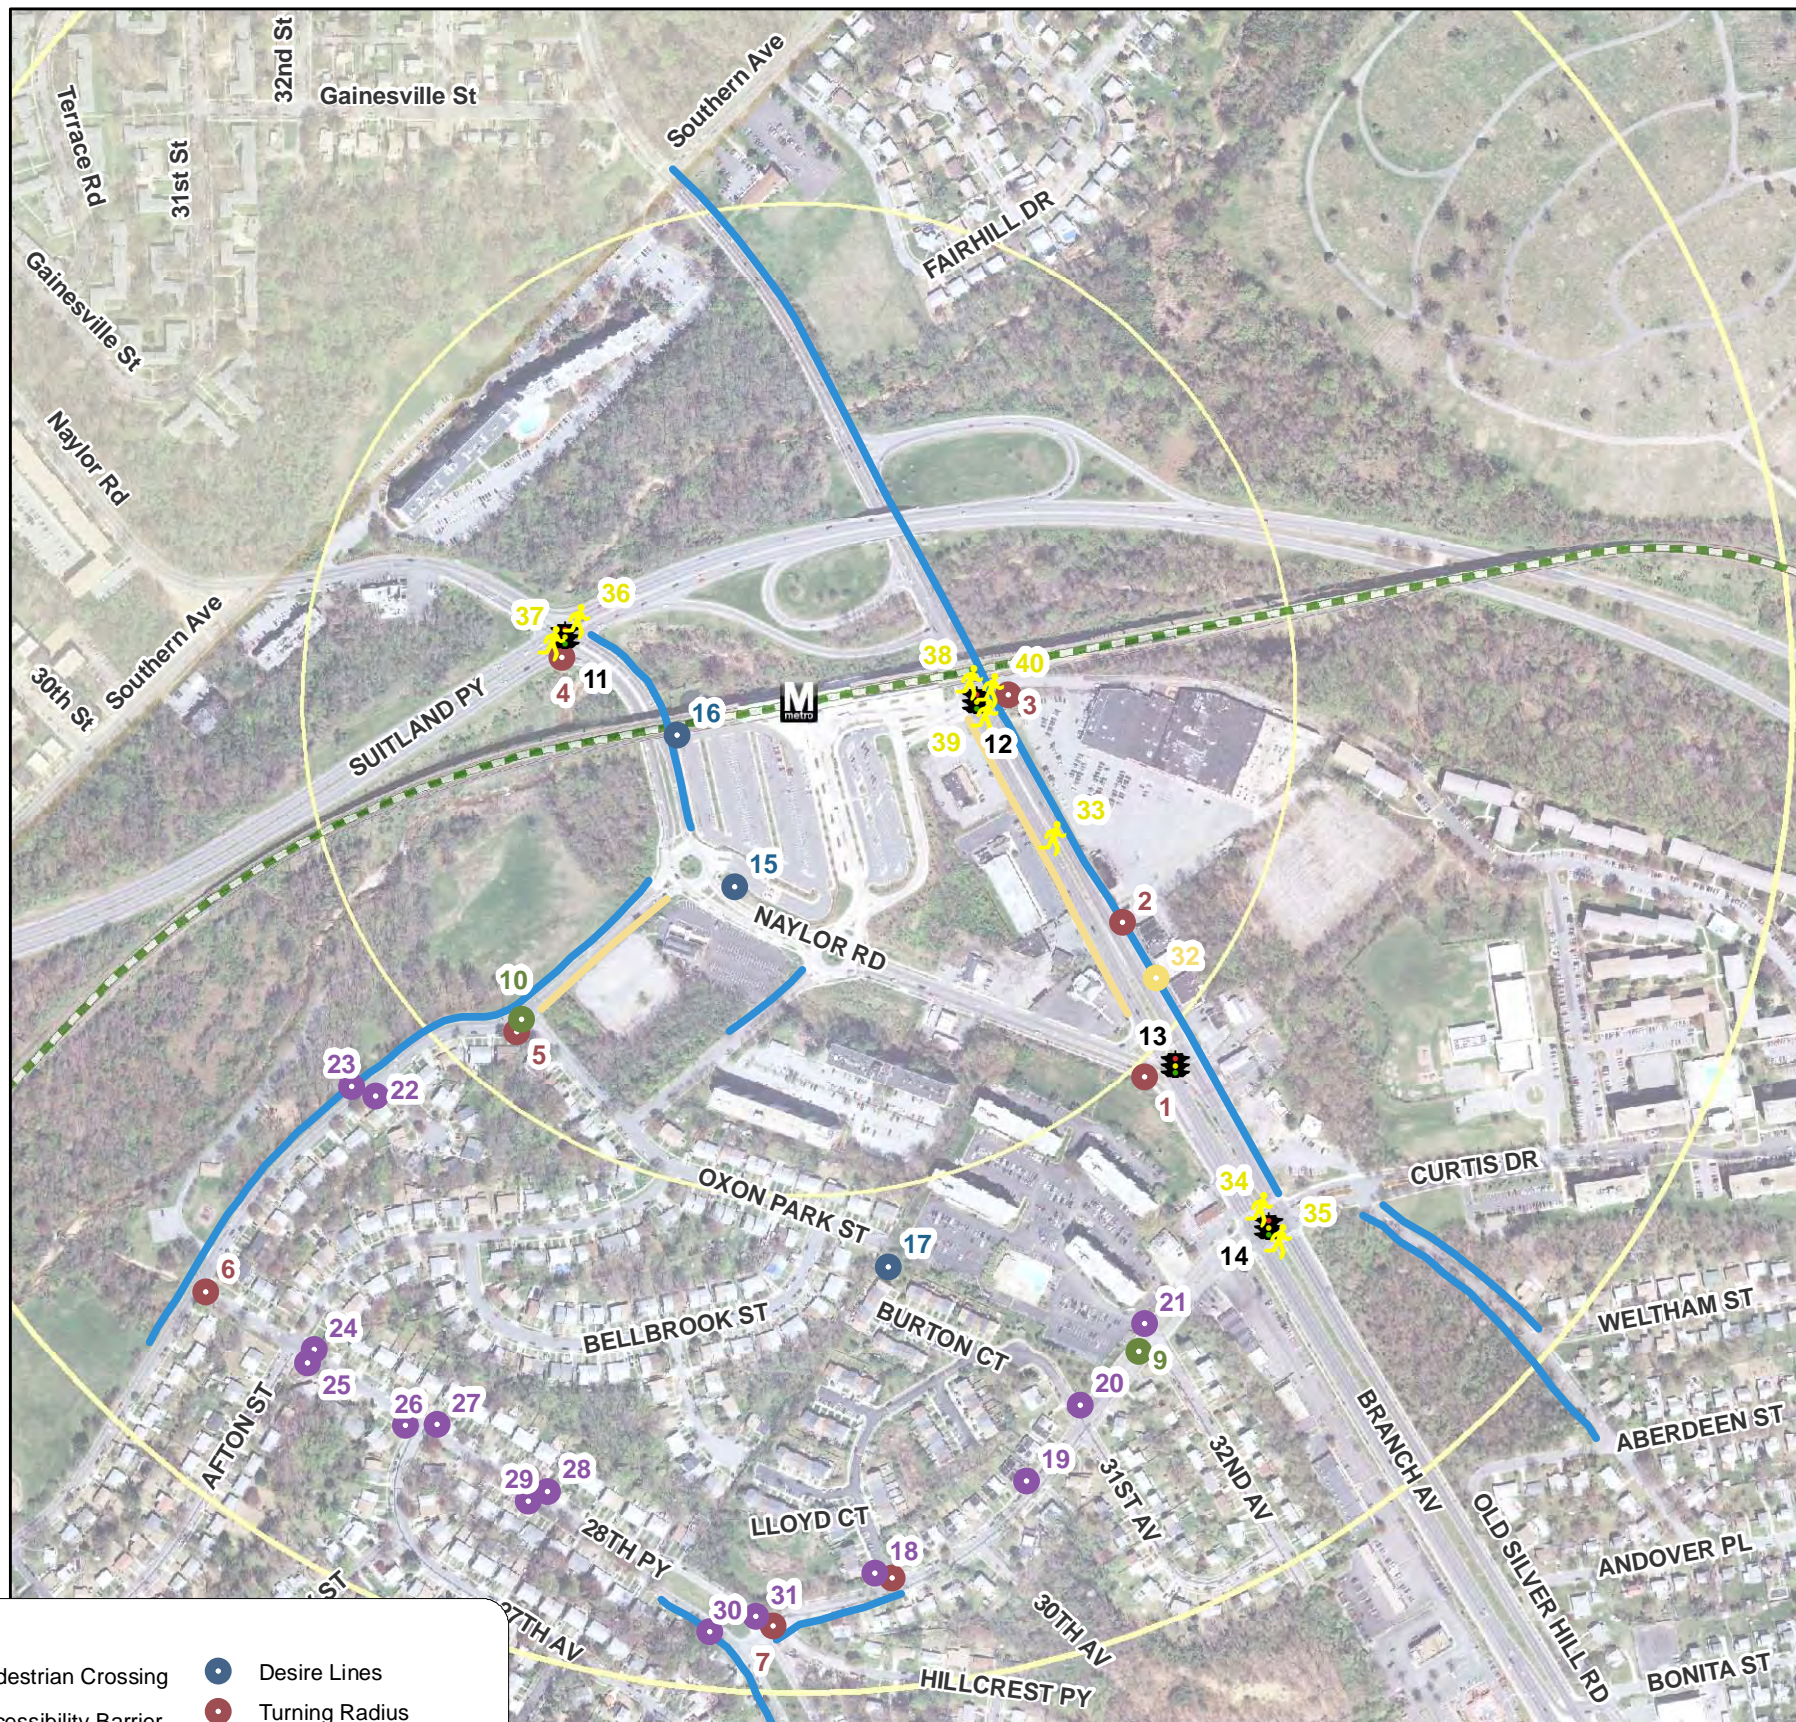
Bicycle and pedestrian access deficiencies were identified during the field visit, and are summarized in this section. The deficiencies are organized around the complete streets principles using specific examples from the Naylor Road study area. As part of the final product for this plan, the project team will identify specific projects to improve each of these areas. Locations of the existing transportation issues are identified in Figure 2. Transportation issues identified in the map are referenced in the following section under the relevant principle.

NUMBER	TYPE	DESCRIPTION
1	Turning Radius	Naylor Road/Branch Avenue
2	Turning Radius	Branch Avenue driveway
3	Turning Radius	Branch Avenue driveway
4	Turning Radius	Suitland Parkway/Naylor Road
5	Turning Radius	Oxon Run Drive/Oxon Park Street
6	Turning Radius	Oxon Run Drive/28th Parkway
7	Turning Radius	28th Parkway/Curtis Drive
8	Turning Radius	Curtis Drive/31st Avenue
9	Wasted Space	Very wide section on Curtis Drive
10	Wasted Space	Very wide intersection at Oxon Run Drive/Oxon Park Street
11	Signal Timing	Long Cycle Length - Suitland/Naylor
12	Signal Timing	Long Cycle Length - Branch/Metro Driveway
13	Signal Timing	Long Cycle Length - Branch/Naylor
14	Signal Timing	Long Cycle Length - Branch/Curtis
15	Desire Lines	Station Access from South
16	Desire Lines	Station Access from Northwest
17	Desire Lines	Burton Court to Oxon Park Street Connection
18	Accessibility Barrier	Stairs on Sidewalk along 31st Avenue
19	Accessibility Barrier	Sidewalk bulge along Curtis Drive

20	Accessibility Barrier	Missing Curb Cut at Curtis Drive/31st Avenue
21	Accessibility Barrier	Missing Curb Cuts at Curtis Drive Apartment Drive
22	Accessibility Barrier	Missing Curb Cuts at bus stop
23	Accessibility Barrier	Missing Curb Cuts and Sidewalk at Bus Stop
24	Accessibility Barrier	Missing Curb Cuts at Bus Stop
25	Accessibility Barrier	Missing Curb Cuts at Bus Stop
26	Accessibility Barrier	Missing Curb Cuts at Bus Stop
27	Accessibility Barrier	Missing Curb Cuts at Bus Stop
28	Accessibility Barrier	Missing Curb Cuts at Bus Stop
29	Accessibility Barrier	Missing Curb Cuts at Bus Stop
30	Accessibility Barrier	Missing Curb Cuts and Sidewalk at Bus Stop
31	Accessibility Barrier	Missing Curb Cuts at Bus Stop
32	Access Management	Very wide driveway along Branch Avenue
33	Pedestrian Crossing	Many pedestrians cross mid-block
34	Pedestrian Crossing	Very long pedestrian crossing
35	Pedestrian Crossing	Very long pedestrian crossing

Study Area: Large turning radii exist at a number of intersections in the study area. See numbers 1-8 in Figure 2.

Study Area: Crossing distances along Branch Avenue (MD 5) and Suitland Parkway are very long and create an uncomfortable environment for pedestrians. Some low-volume roads also have long crossing distances, but are less threatening. See numbers 34 and 35 in Figure 2.

Study Area: Most roadways in the study area have sufficient crossing opportunities, with the exception of Branch Avenue and Suitland Parkway. There appears to be little demand for additional at-grade crossings of Suitland Parkway. Improving crossing options on Branch Avenue is a high priority. See number 33 in Figure 2.

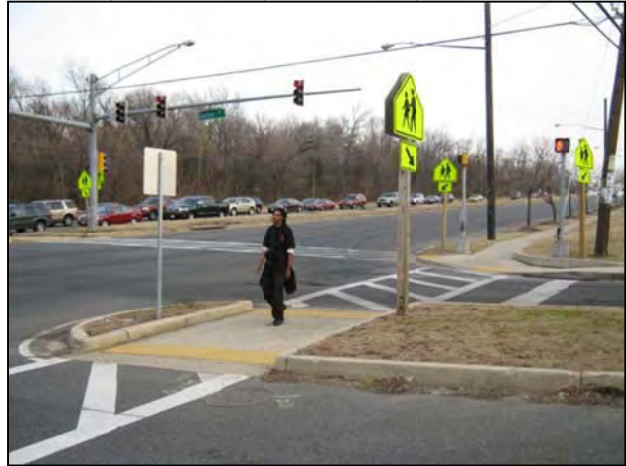
Photo Caption: A pedestrian refuge island is provided on Curtis Road at its intersection with Branch Avenue.

Study Area: Pedestrian refuge islands are common along Branch Avenue and Naylor Road, but some difficult crossings still exist (Suitland Parkway/Naylor Road).

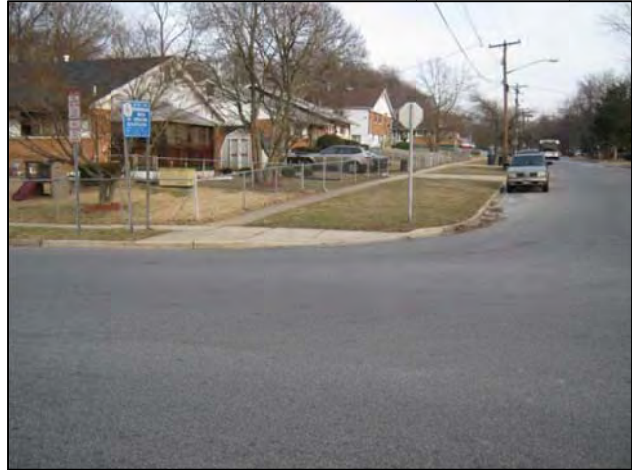
Photo Caption: The intersection of Oxon Run Drive/28th Parkway has a large turning radius which permits vehicles to turn while maintaining high speeds. Tightening this and other radii will force drivers to slow down and reduce the chance of not seeing pedestrians crossing the street.

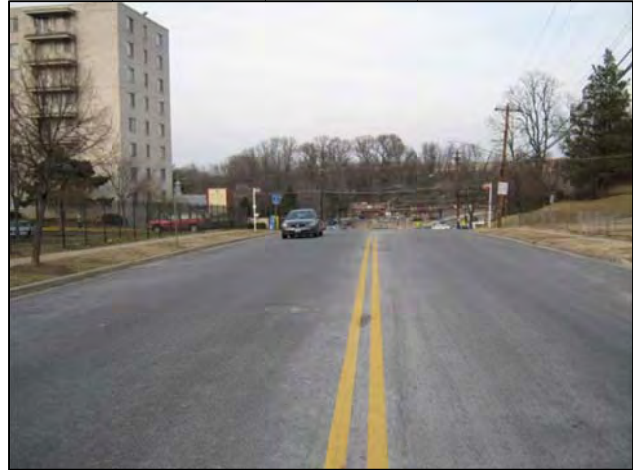
Photo Caption: Curtis Road is 46 feet wide, well over what is needed for two lanes of traffic and two parking lanes. Reallocation of this space could provide bicycle lanes and/or wider sidewalks.

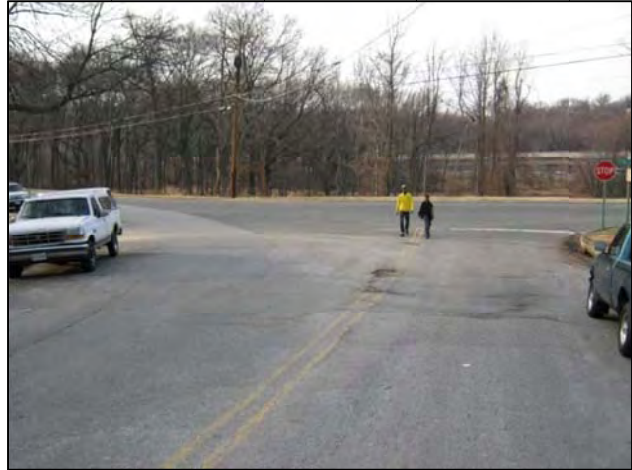
Photo Caption: The intersection of Oxon Run Drive/Oxon Park Street is excessively large and encourages fast turning movements. Tightening this intersection would calm traffic and reduce pedestrian crossing distance.

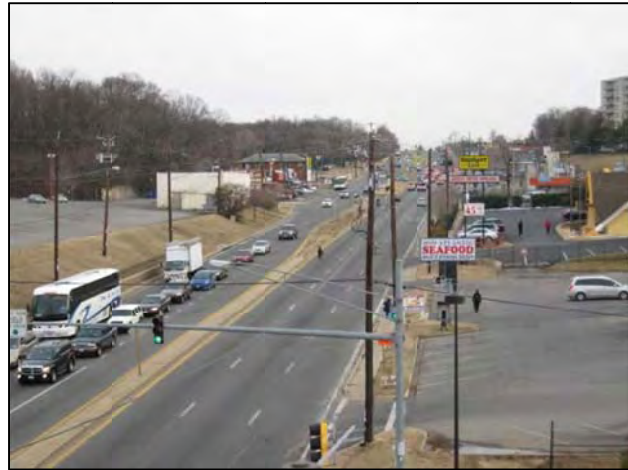
Photo Caption: Many pedestrians cross Branch Road (MD 5) at midblock locations due to long traffic signals and large spacing between controlled crossing opportunities.

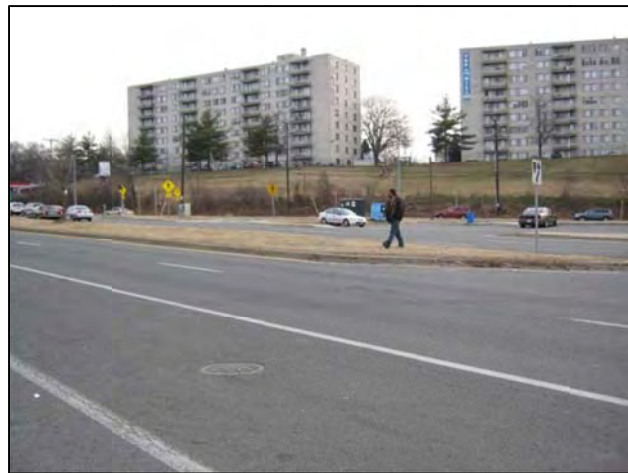
Photo Caption: An auto-oriented shopping center with far more parking than is demanded. The buildings do not front the street, nor is a sidewalk provided.

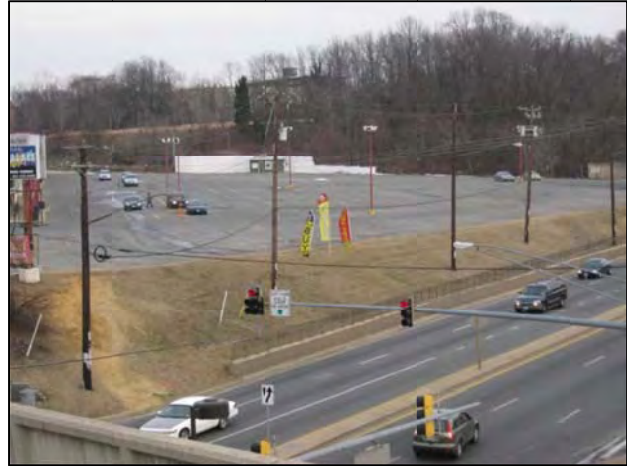
Study Area: Auto-oriented development is commonplace in the Naylor Road Station area, particularly along Branch Avenue (MD 5), with destinations set back from the road and parking placed along the property frontage. Reducing the number of driveways and encouraging street front development will improve the pedestrian experience.

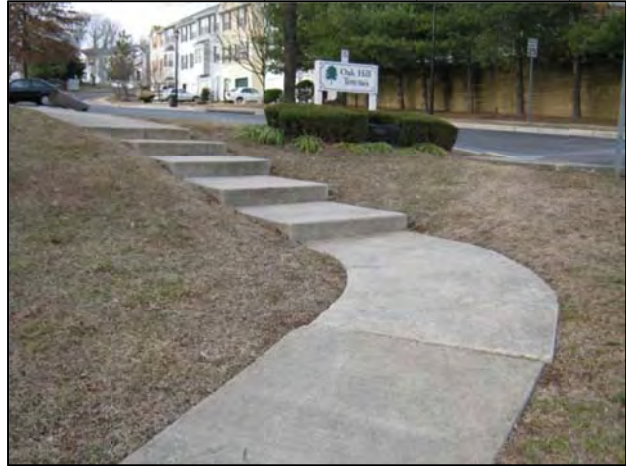
Photo Caption: The sidewalk along 31st avenue features stairs which are inaccessible for some mobility impaired pedestrians.

Study Area: Inaccessible sidewalk features are found throughout the study area, including missing curb cuts, unavoidable barriers, and inaccessible bus stops. See numbers 18-31 in Figure 2.

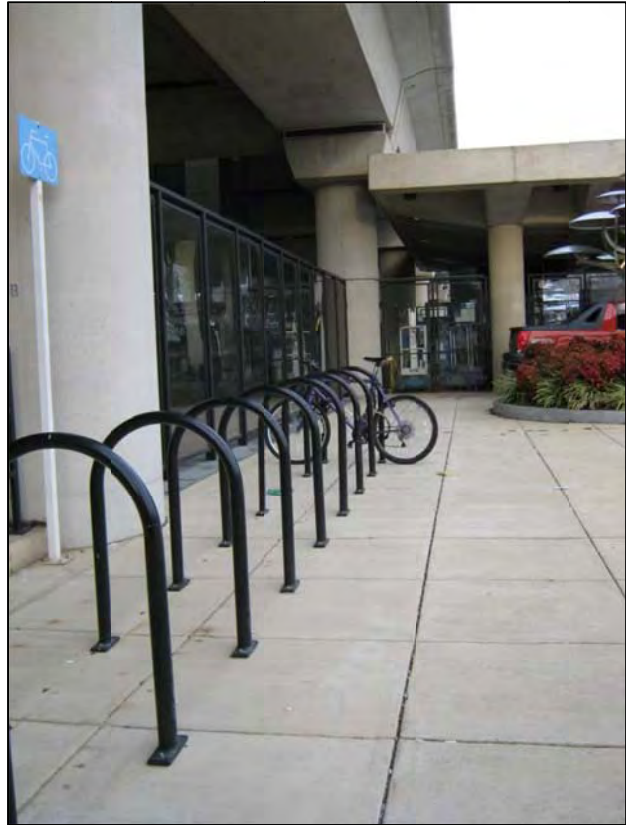
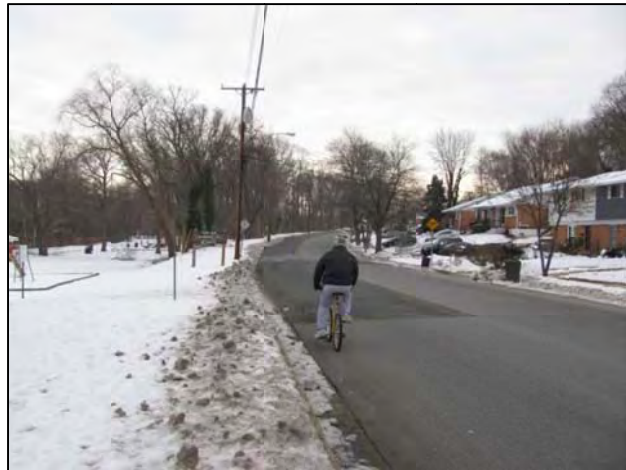
Photo Captions: Only a handful of bicycles were observed parked at the Naylor Road Metro station on several visits to the station (top). A cyclist rides on the wrong side of the road on Oxon Run Drive (bottom).

Study Area: Very little bicycle activity was observed in the study area, likely due in part to the lack of accommodation for cyclists and high volumes and speeds along major thoroughfares like Branch Avenue (MD 5) and Naylor Road (MD 637).

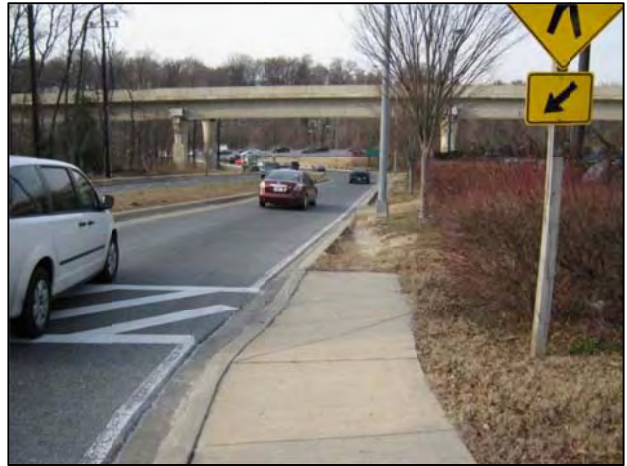
Photo Caption: A sidewalk abruptly ends on Naylor Road. While there is a sidewalk on the other side of the road, it forces pedestrians to cross.

Missing sidewalks are relatively common in the station area, and are identified in Figure 2.

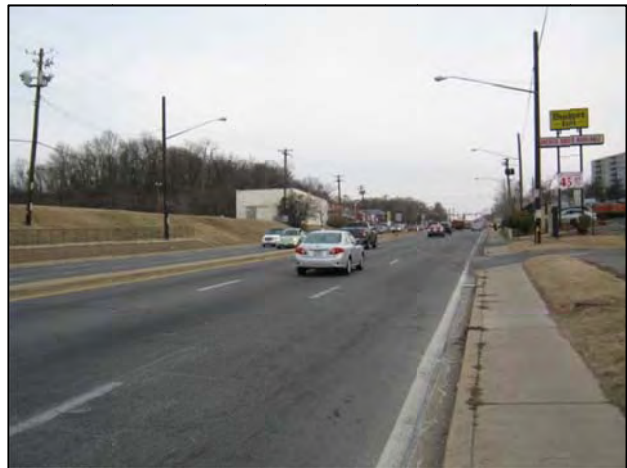
Photo Caption: The width of the sidewalk on Branch Avenue (MD 5) frequently changes, with several narrow sections that are uncomfortable for pedestrians.

Study Area: Inadequate sidewalks are found along portions of Branch Avenue (MD 5) and Oxon Run Drive, and are identified in Figure 2.

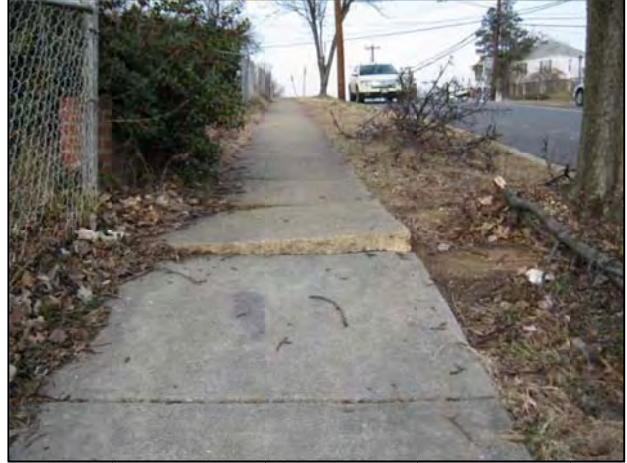
Photo Caption: The tree's roots have caused the sidewalk to bulge creating a tripping hazard and barrier for wheel-chair users.

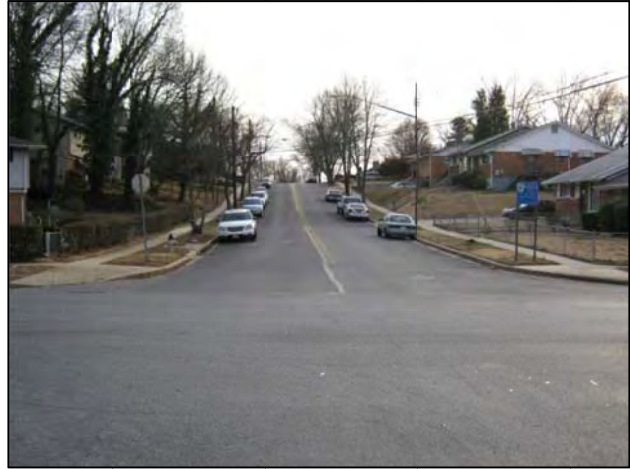
Photo Caption: An unmarked crossing along 28th Parkway.

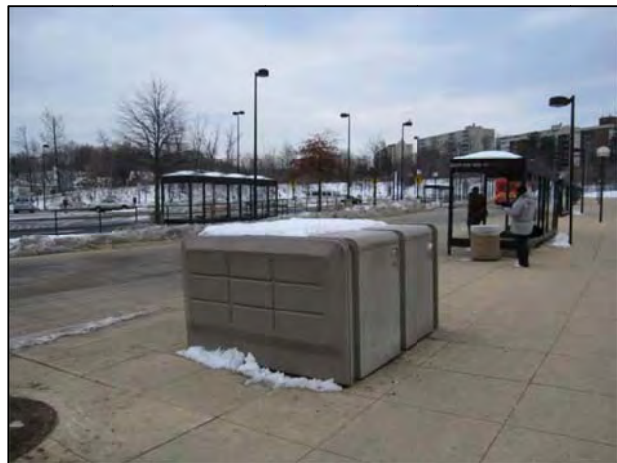
Photo Caption: Bike lockers at the Naylor Road Metro Station provide secure bicycle storage and encourage bike access to transit.

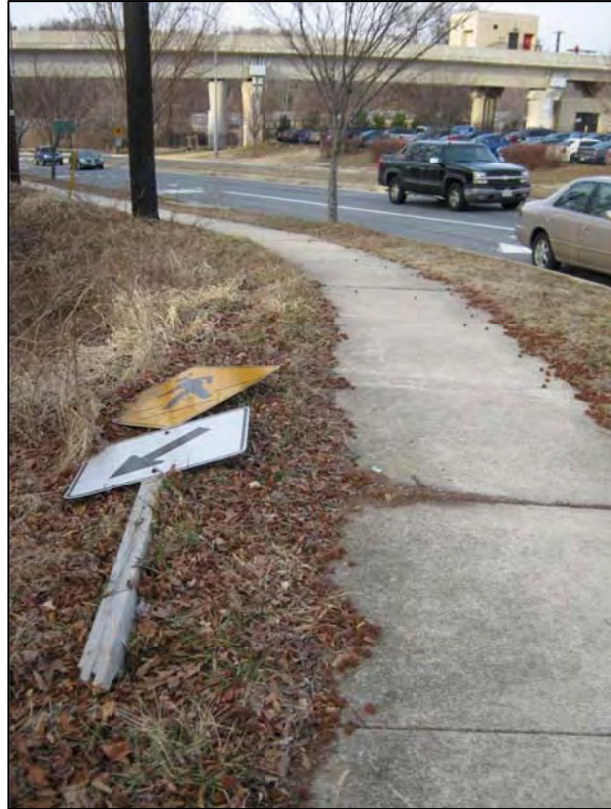
Photo Caption: A pedestrian crosswalk sign along Naylor Road has been knocked down.

Study Area: A number of unsignalized crossings are found along Naylor Road and Oxon Run Drive near the Metro Station, where high levels of pedestrian and auto activity interact. Driver compliance at these locations was very low.

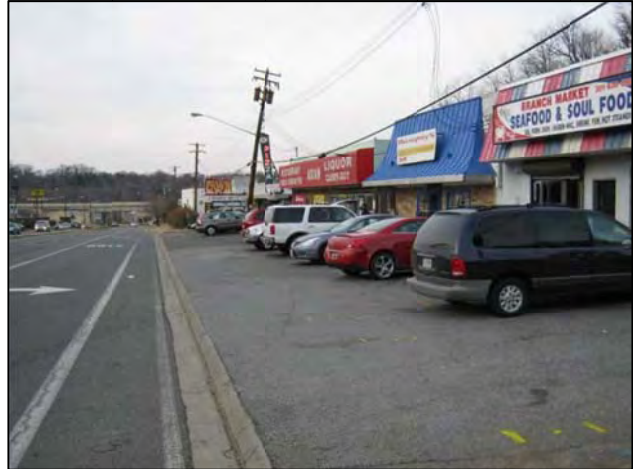
Photo Caption: Strip development along Branch Avenue (MD 5) features dangerous access frontage and lacks designated pedestrian facilities.

Study Area: Branch Avenue (MD 5) has dangerous access configurations along the road through the study area.

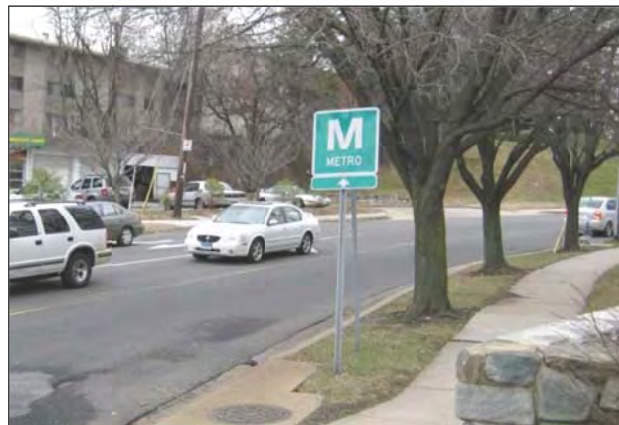
Photo Caption: An example of a sign directing travelers to the Metro Station.

Study Area: Limited wayfinding is found in the station area.

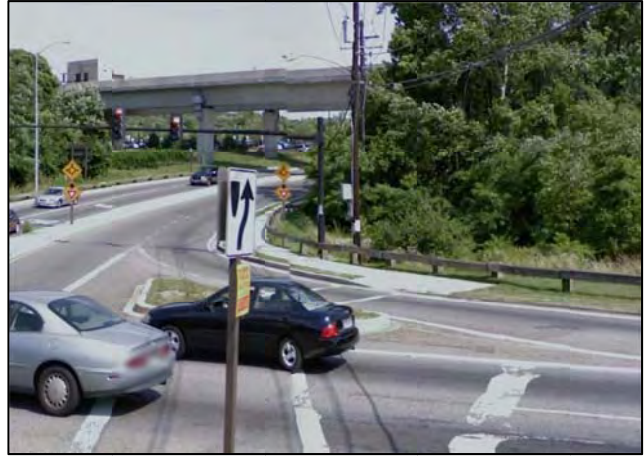
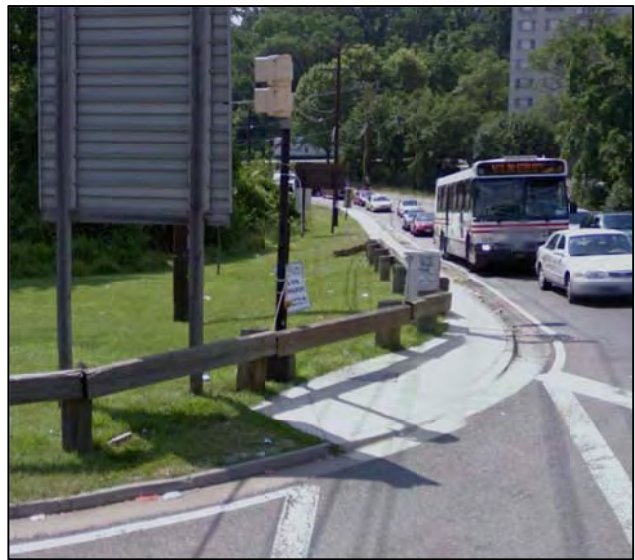
Photo Caption: Pedestrian signal heads at the intersection of Suitland Parkway/Naylor Road are either missing or misplaced.

Study Area: Several intersections in the study area are missing pedestrian signals on some or all approaches, including Suitland Parkway/Naylor Road and the Metro Station access driveway along Branch Avenue. See numbers 38-40 in Figure 2.

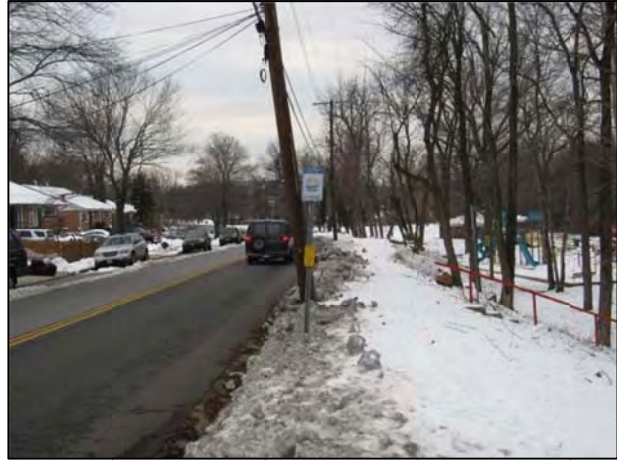
Photo Caption: A bus stop made virtually inaccessible in winter. Riders would have to stand in the street to wait for the bus.

Study Area: Bus transfers within the Naylor Road Metro Station property are very well established and provide a high level of amenity. However, the bus stops located outside of the station in the study area are no more than signs installed on the side of the road.

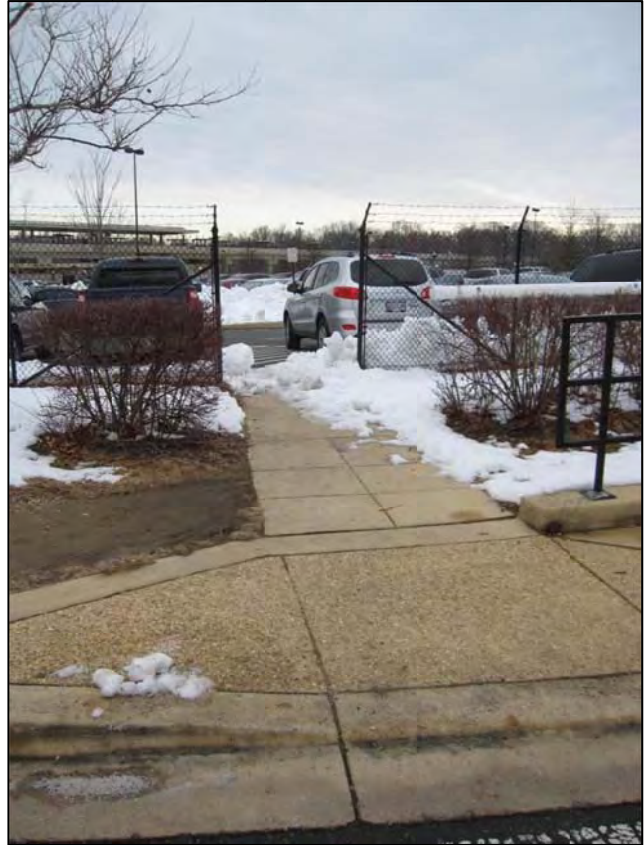
Photo Caption: A small gap in the Naylor Road Station fence is provided for pedestrian access to the station. The fence, which is not intended to completely prohibit access (there are openings in several locations), is equipped with barbed wire on the top to prevent climbing.

Study Area: The Naylor Road station, surrounded by a tall fence with barbed wire, discourages and inconveniences pedestrian access. Some pedestrians (accessing from Naylor Road to the north) are required to walk an additional 700 feet in order to reach the nearest opening in the fence. It is not apparent what purpose this fence serves, and options to reduce or remove the fence should be pursued.

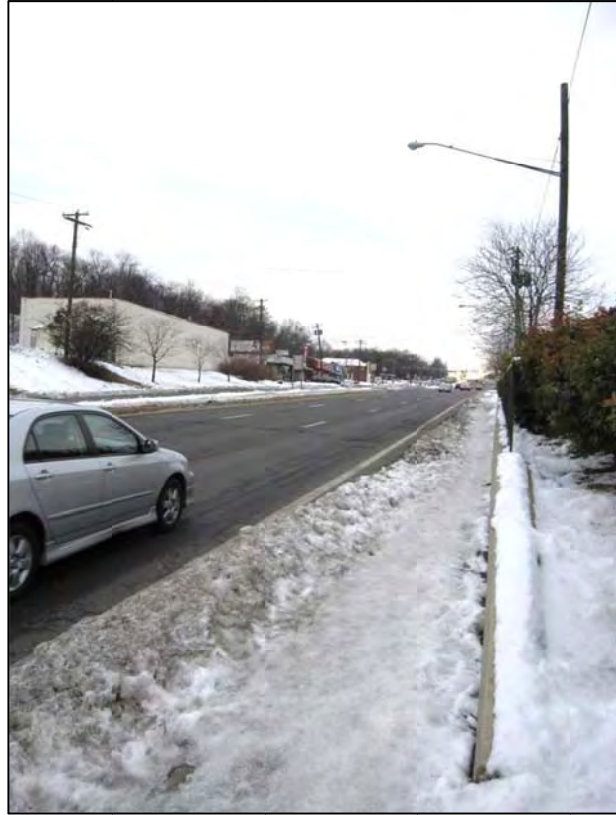
Photo Caption: A snow- and ice-covered sidewalk along Branch Avenue (MD 5) forces pedestrians to walk in the street to access the Metro station.

Station Area: Snow removal on sidewalks is a significant problem throughout the study area, particularly along Branch Avenue.

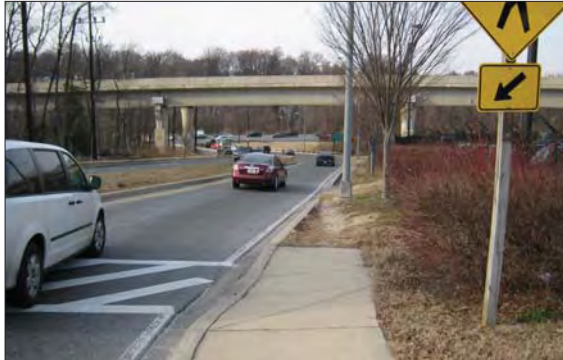
A sidewalk abruptly ends on Naylor Road. While there is a sidewalk on the other side of the road, it forces pedestrians to cross.

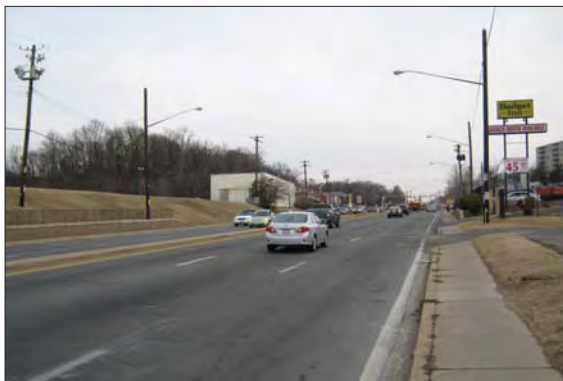
The width of the sidewalk on Branch Avenue (MD 5) frequently changes, with several narrow sections that are uncomfortable for pedestrians.

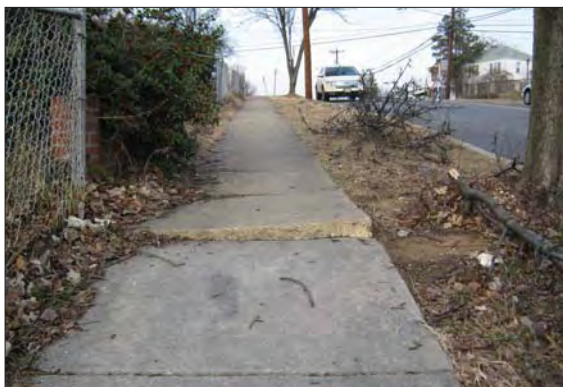
The tree's roots have caused this sidewalk to bulge creating a tripping hazard and barrier for wheel-chair users.

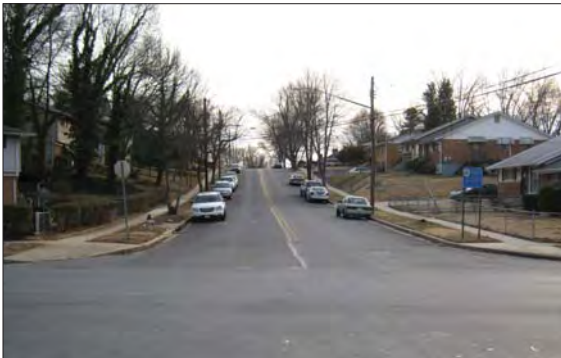
An unmarked crossing along 28th Parkway.

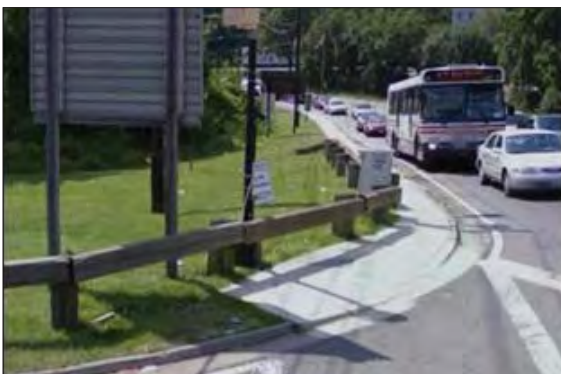
Pedestrian signal heads at the intersection of Suitland Parkway/Naylor Road are either missing or misplaced.

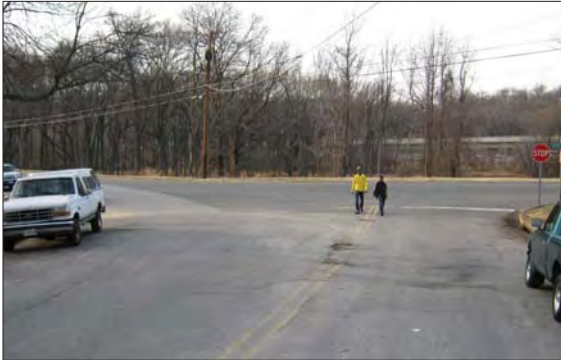
The intersection of Oxon Run Drive/Oxon Park Street is excessively large and encourages fast turning movements. Tightening this intersection would calm traffic and reduce pedestrian crossing distance.

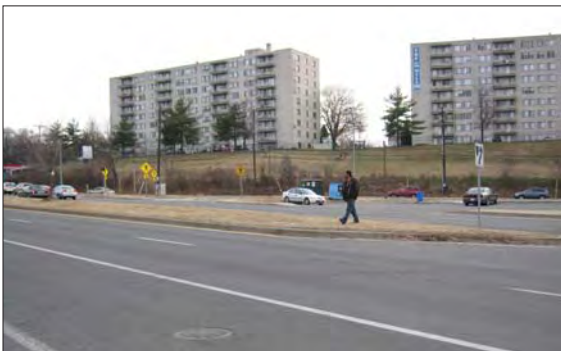
Pedestrian crossing mid-block on Branch Avenue.

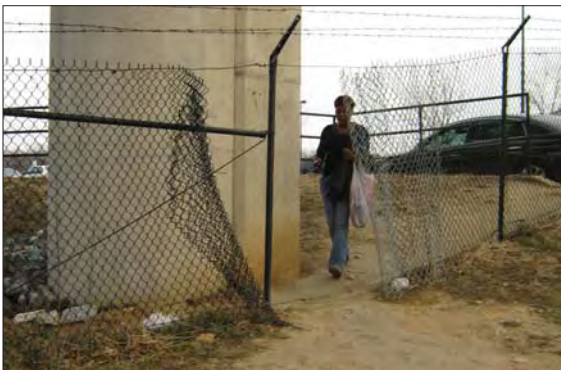
This fence around the Naylor Road Metro station is located at a natural pedestrian access point and has been repeatedly cut open and repaired.

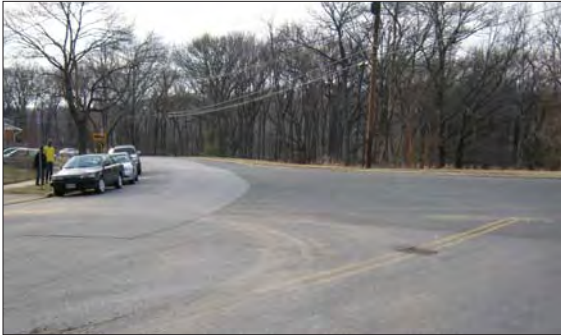
The intersection of Oxon Run Drive/28th Parkway has a large turning radius which permits vehicles to turn while maintaining high speeds.

Curbs with large turning radii for right-turn movements encourage motorists to make the turn at a high rate of speed. This can be very dangerous and inhospitable for pedestrians. Designing turning radii to slow turning vehicles can be effective for reducing speeds and improving safety.

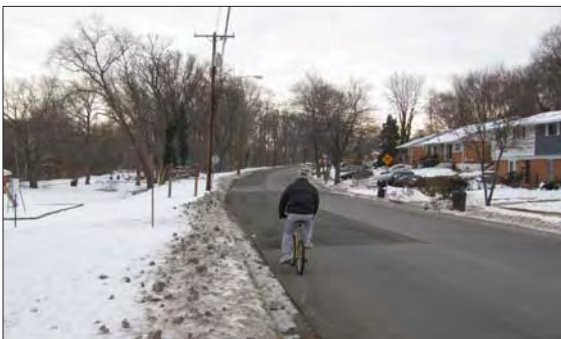
Cyclist traveling on Oxon Run Drive on the wrong side of the street on a roadway with no bicycle facilities.

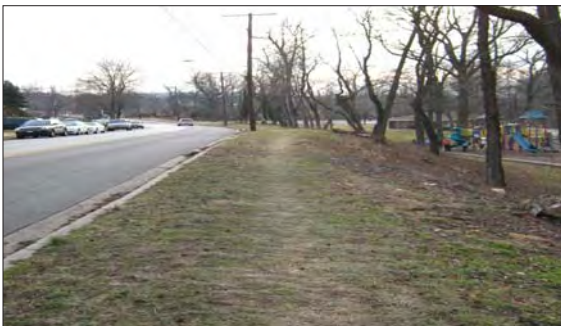
The desire path along the north side of Oxon Run Drive could provide a connection to the proposed Oxon Run Trail.

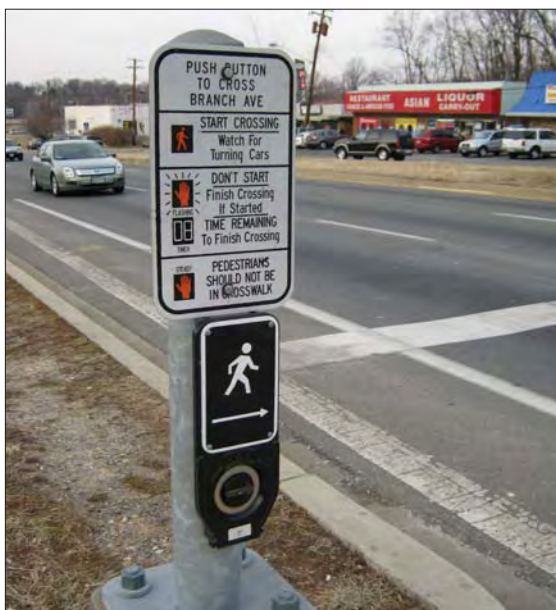
A pedestrian push-button is provided to cross Branch Avenue at Naylor Road. Actuation demonstrates that pedestrians have been planned for, and this type of button provides audible feedback to the user. However, automatic pedestrian signals reduce delay for pedestrians.

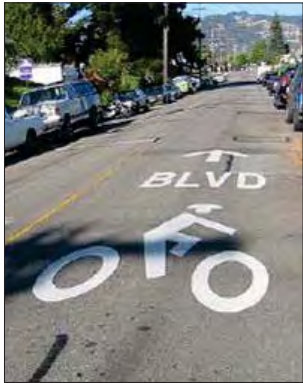
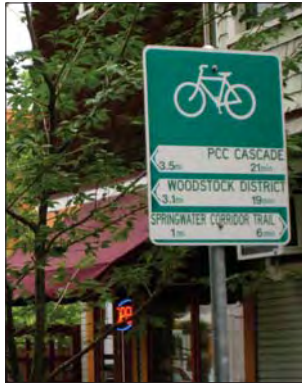
Wayfinding

Signs directing pedestrians and bicyclists towards destinations in the area, typically including distance and average walk/cycle times.
