Naylor Road Metro Station Area Accessibility Study

Pedestrian and Bicycle Metro Station Access
Transportation Land-Use Connection (TLC)

The Maryland-National Capital Park and
Planning Commission

May 2011

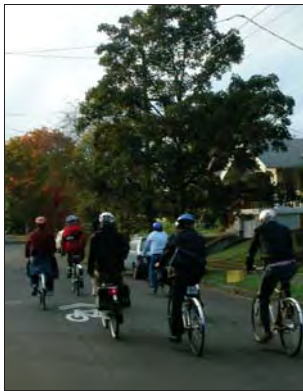
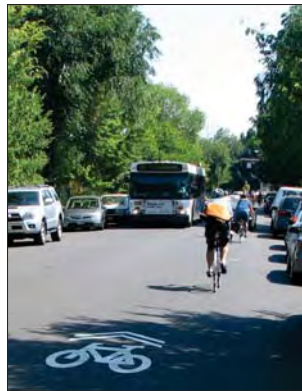
Bicycle Sharrows

A shared-lane marking, or sharrow, is a pavement marking that can be used where space does not allow for a bike lane. Sharrows remind motorists of the presence of bicycles and indicate to cyclists where to safely ride within the roadway.

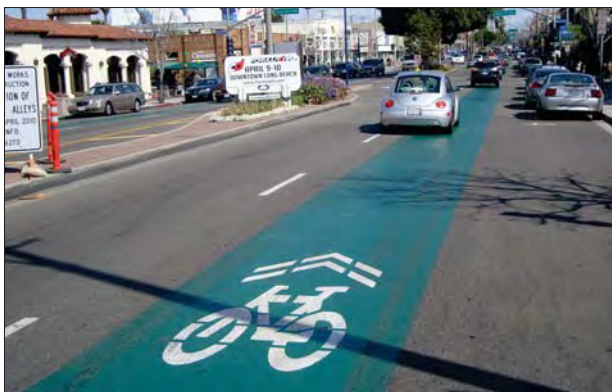
Enhanced Sharrows

ADVANTAGES	CHALLENGES	LOCATION TYPE
<ul style="list-style-type: none"> Further the benefits provided by normal sharrows 	<ul style="list-style-type: none"> Pavement marking maintenance Not as effective as a bike lane 	<ul style="list-style-type: none"> Streets with limited space for bike lane markings

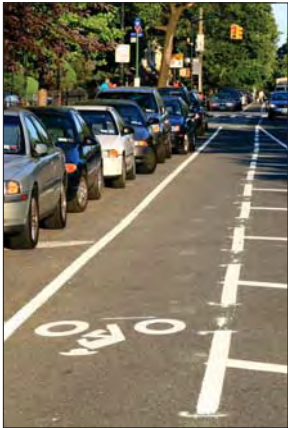
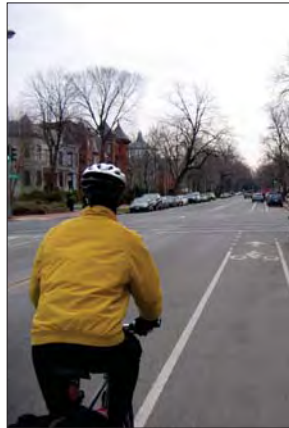
Bike Lane Markings

The area of roadway designated for non-motorized bicycle use, separated from vehicles by pavement markings.

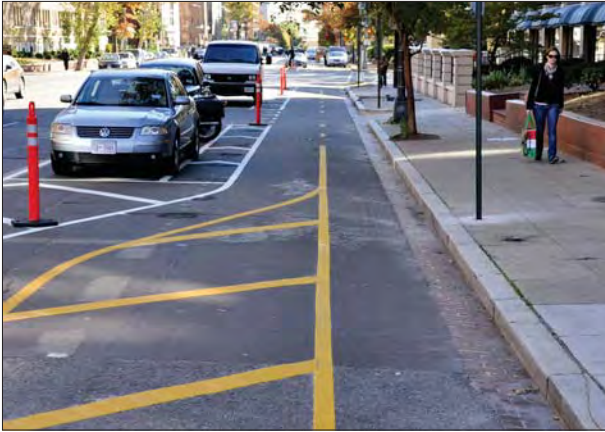
Cycle Track

An exclusive bike lane separated from vehicle travel lanes, parking lanes, and sidewalks. Any parking is moved adjacent to moving traffic and bike lane is next to curb. They can be one-way, two-way, at street level, at sidewalk level, or at an intermediate level.

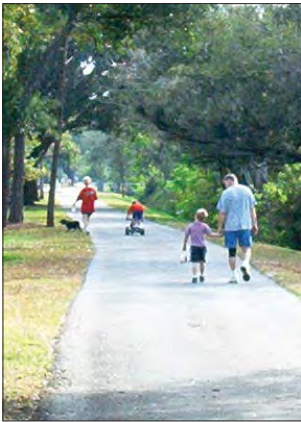
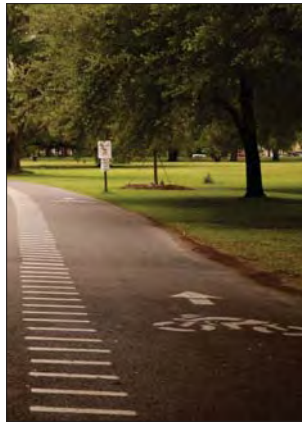
Multiuse Pathways

Paved pathways away from the road and out of the path of turning vehicles designed with space adequate for safe use by both pedestrians and bicyclists.

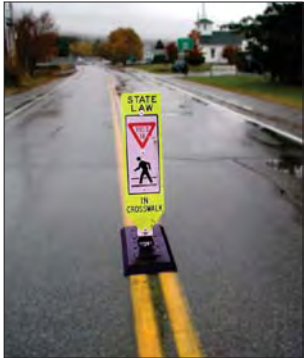
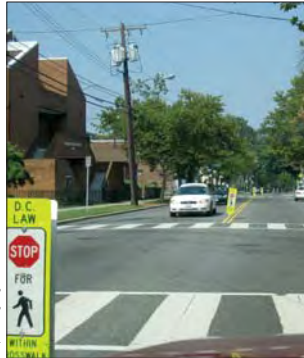
In-Street "Yield for Pedestrians" Signs

Signs placed in the middle of crosswalks to increase driver awareness of pedestrians and the legal responsibility to yield right-of-way to pedestrians in crosswalk.

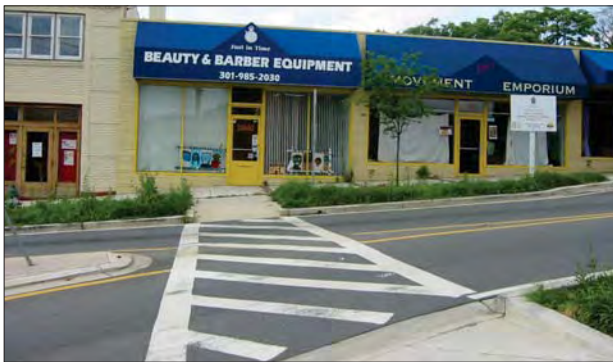
High Visibility Crosswalks

Clear, reflective roadway markings and accompanying devices at intersections and priority pedestrian links, located only where motorists should expect pedestrians with sufficient sight distance and reaction time.

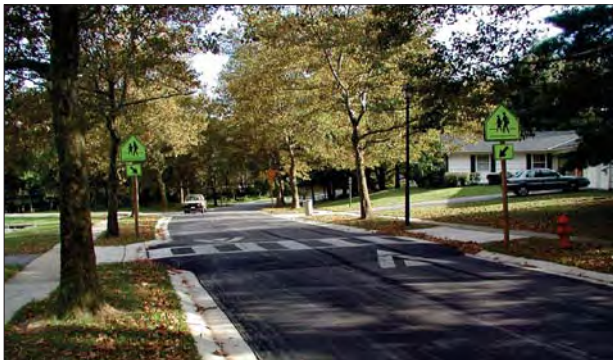
Raised Crosswalk

A pedestrian crossing area raised higher to give motorists and pedestrians a better view of the crossing area. A raised crosswalk is essentially a speed table marked and signed for pedestrian crossing.

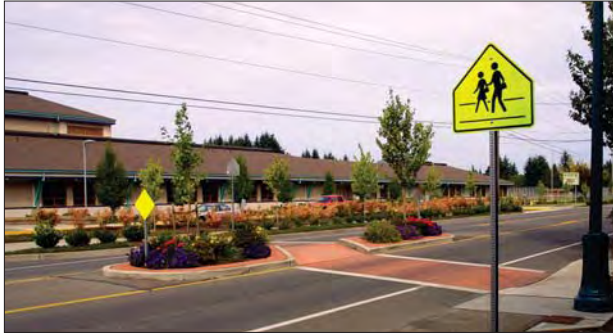
Raised Median Islands/Pedestrian Refuge Area \$4,000 - \$30,000 per crossing
Provides a protected area in the middle of a crosswalk for pedestrians to stop while crossing street.

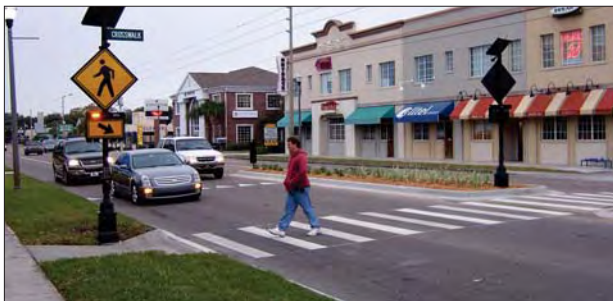
Rectangular Rapid Flash Beacon \$12,000 - \$15,000 for both directions
Signs with a pedestrian-activated "strobe-light" flashing pattern that attracts attention and notifies motorists that pedestrians are crossing

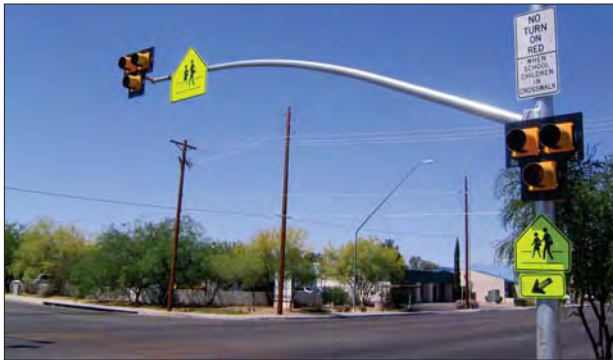
Pedestrian Hybrid Signal (HAWK) \$50,000 - \$75,000 per crossing
Pedestrian activated signal, unlit when not in use, begins with a yellow light alerting drivers to slow, and then a solid red light requires drivers to stop while pedestrians have the right-of-way to cross the street. The example shown is at Georgia Avenue and Hemlock Street.

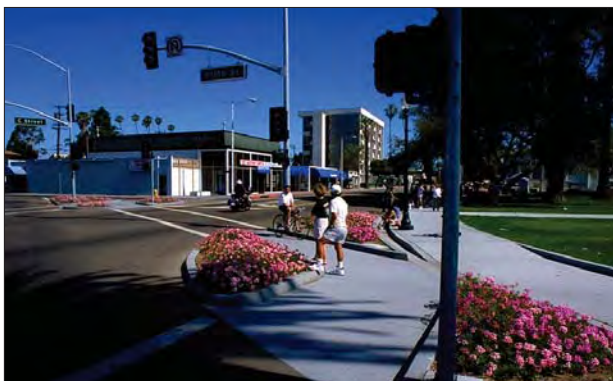
Reduced Curb Radii \$5,000 - \$30,000 per corner
Reconstructing a street corner with a smaller radius to reduce vehicle turning speeds.

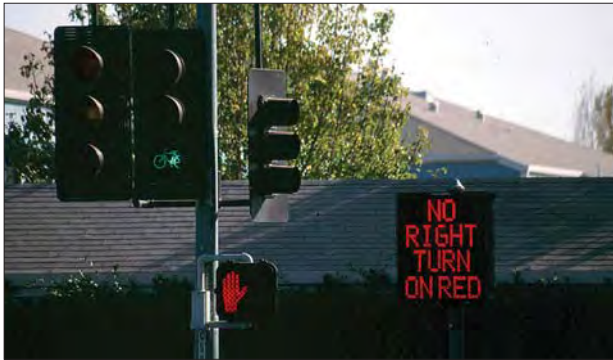
Prohibit Right-Turns on Red

Mounted sign eliminates the right of motorists to make a right turn at a red light. Can be used full-time or under restricted time intervals.

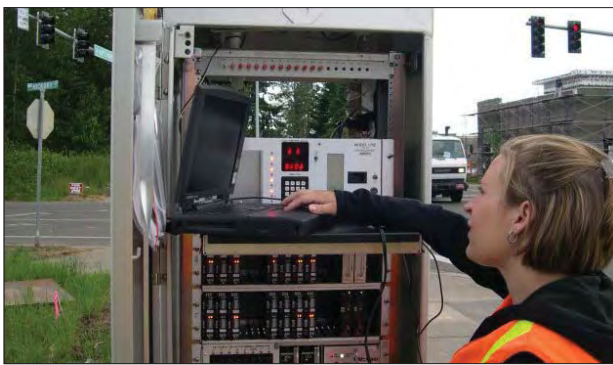
Signal Timing Modification

Adjustments of existing signal timings to more readily accommodate all modes. Could include reducing cycle lengths to decrease the amount of time pedestrians wait at signals.

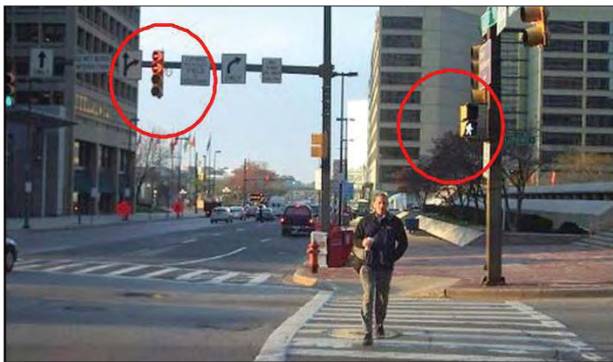
Leading Pedestrian Interval

Pedestrians are given advance time to begin crossing at the crosswalk before conflicting vehicles start moving.

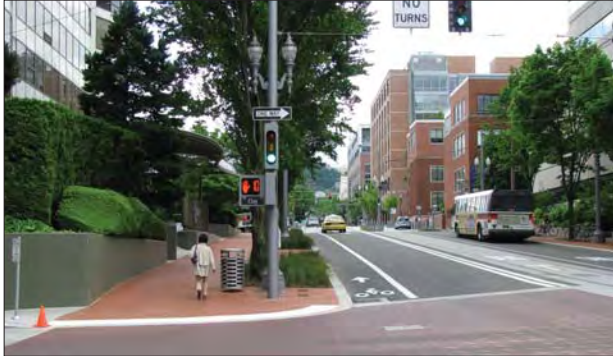
Pedestrian Countdown Signals

Walk/Don't Walk pedestrian signals with countdown signal informing pedestrians of the time remaining to cross the street.

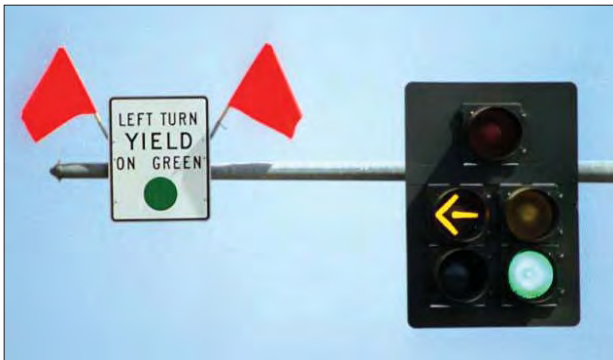
Protected Left-Turns

Allows left turning vehicles a protected movement (i.e., no conflicting movements), generally involving the installation of a left-turn arrow.

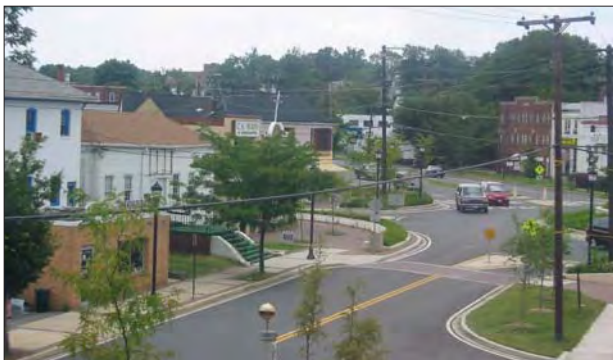
Modify Existing Lanes or Geometry

Modify the existing intersection geometry to respond to conditions including reducing pedestrian crossing exposure to traffic, adding or eliminating a traffic movement, creating space for the type and level of pedestrian activity.
